LEAD PAINT INSPECTION REPORT

CITY OF VICTORVILLE

1 4499 Residences
14491 Turner Road
Victorville, Ca 92394

**LEAD BASED PAINT INSPECTION REPORT
RESIDENCES
14491 TURNER ROAD
VICTORVILLE, CA 92384**

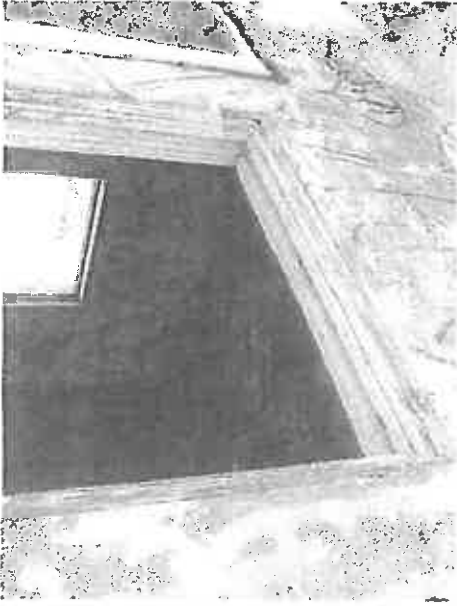
PHOTO # 1 Window Casing-House 1	PHOTO # 2 Door Casing and Jamb-House 1	PHOTO # 3 Window Sash-House 1

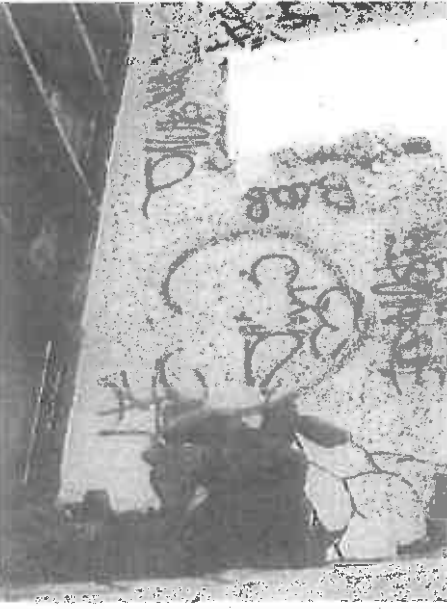
<p>PHOTO # 10 Wall-House 1</p>	<p>PHOTO # 11 Cabinet Side and Shelf-House 1</p>	<p>PHOTO # 12 Tile Counter-House 1</p>

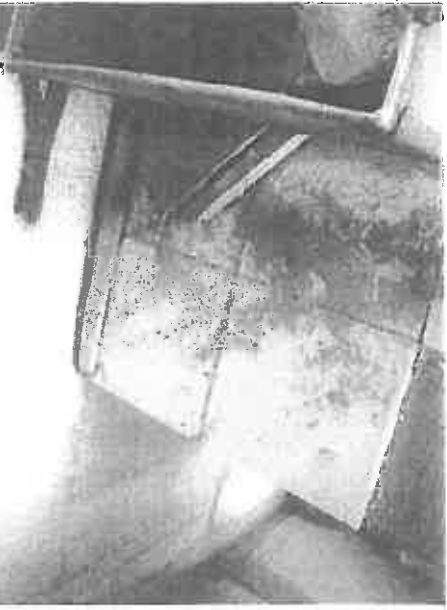
Many ceramic tiles contain lead in pigment and glaze. Although they were not painted, as part of AAA LEAD'S normal inspection process, we also tested tile surfaces. This information may be useful if any abatement or remodeling will take place on these surfaces. THE CERAMIC TILE TRIM IN THE POOL AND THE CERAMIC TILE BACKSPLASH IN AREA-5 IN HOUSE-1 CONTAINS LEAD AT OR ABOVE THE HUD ACTION LEVEL. See tables under TAB 3 of this report for test locations.

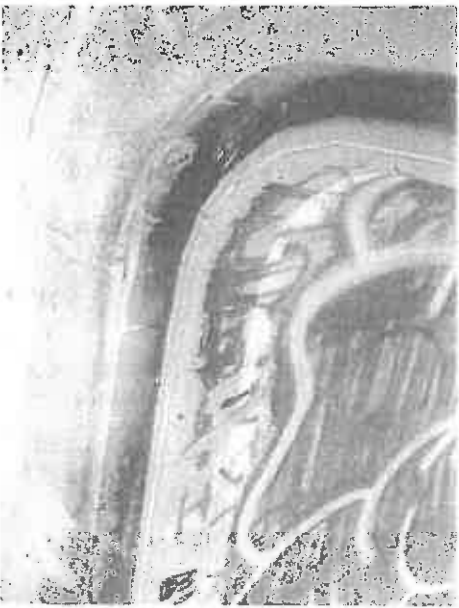
The overall paint condition of both buildings and the pool is poor. Both structures have been fire damaged and vandalized. The lead painted components are in poor condition and need to be stabilized. The ceramic tile in the pool tested positive for lead. Many lead hazards were identified during the inspection.

PHOTO #13 Pool Trim	PHOTO #14 Soffit-House 2	PHOTO #15 Window Casing-House 2

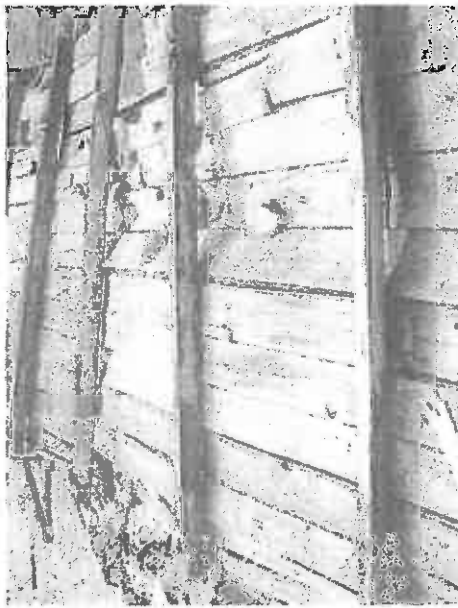
PHOTO #16 Soffit and Rafter-House 2	PHOTO #17 Stucco Wall-House 2	PHOTO #18 Door Jamb-House 2
